Paper ID: 88-30
**MOMCHILGRAD-SEDLARE PEDESTRIAN SUSPENSION
BRIDGE**

This article reviews the new superstructure and cable system for the pedestrian suspension bridge over Varbitza river, situated in Rodopi mountain of Bulgaria. The bridge connects the town of Momchilgrad with the village of Sedlare, bridging the river in a single span. The distance between the two concrete pylons is 169m. The span of the main steel truss girders is 155m with a clear distance between them of 2,50m. The design was made in 2005 and the bridge was constructed in 2007. In 2021 (nearly fifteen years after its completion) side inspection of its service condition was made by the authors. The results of the findings are discussed in this article as well.

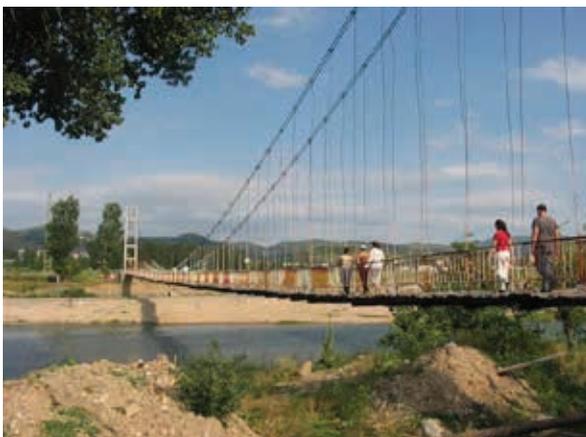
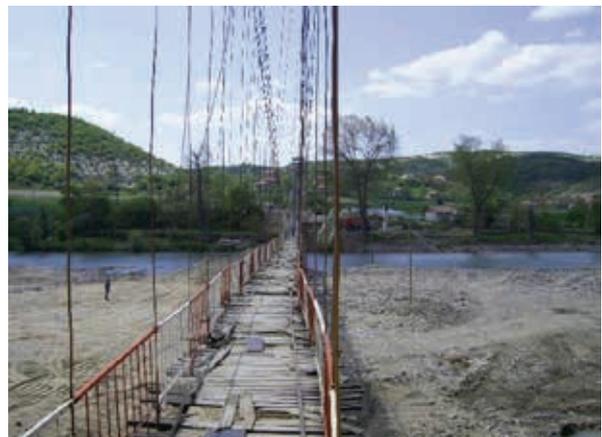
Figure 1: Bridge superstructure before the reconstruction

The project for the reconstruction of the existing suspension bridge, between the town of Momchilgrad and the village of Sedlare, over the Varbitza river, was initiated by the Municipality of Momchilgrad in 2005. The existing superstructure was in a very bad condition (Figure 1) and needed replacement. The project also included strengthening of the concrete pylons and one-sided concrete ramp as well as the design of new anchor blocks for the main cables.
